Applications for Section 404 and 401 Permits

Riverpointe Public Infrastructure Project
St. Charles, St. Charles County, Missouri

CMT Job Number: 19043402-00

NOVEMBER 12, 2020

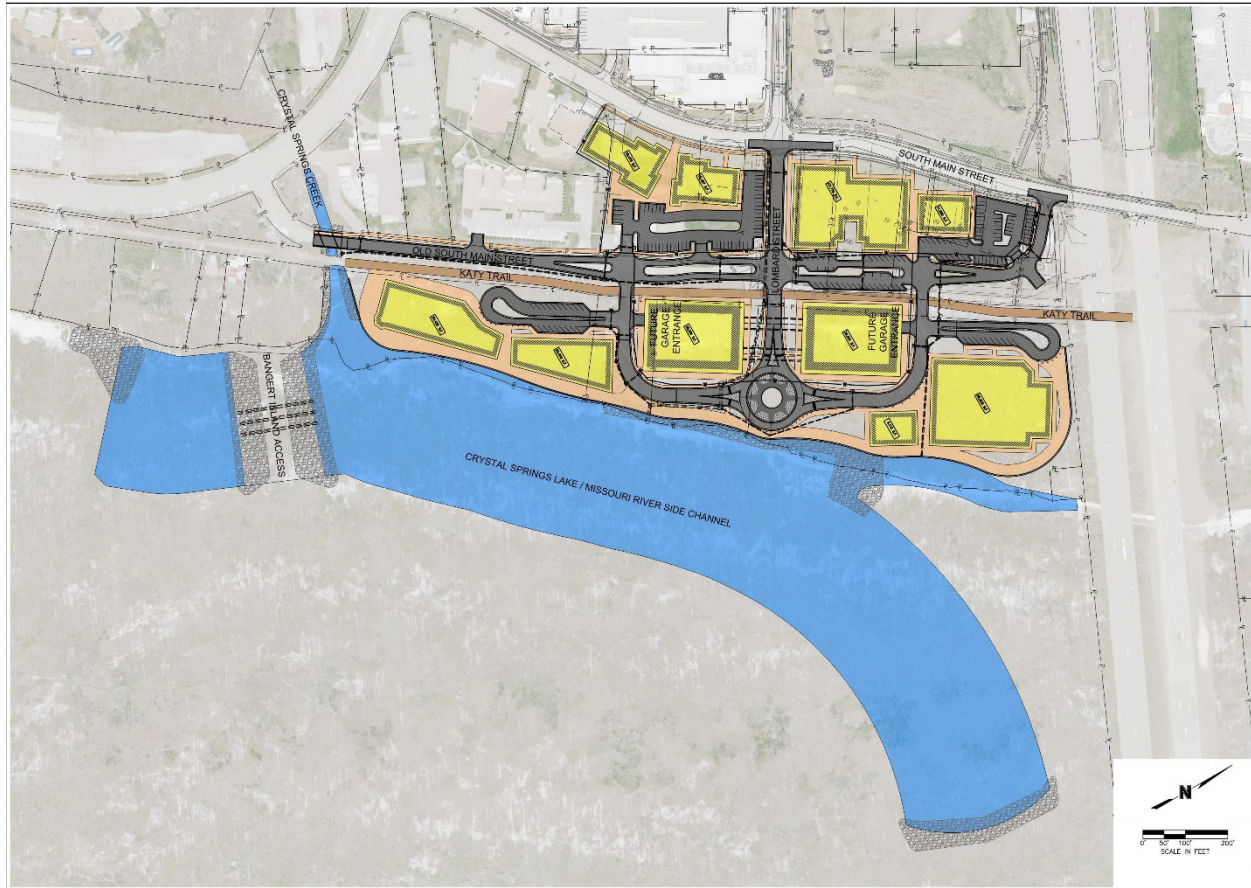
ALTERNATIVE 5: CRYSTAL SPRINGS CREEK MINIMIZED

Under this alternative, Crystal Springs Creek would be impounded to create a smaller Crystal Springs Lake. Similar to Alternative 4, economic development area would impact an estimated 10 acres of wetland, excluding the area for the lake. While this alternative would support economic development within the City of St. Charles, promote multi modal transportation, it would fail to provide enough economic development potential to be feasible.

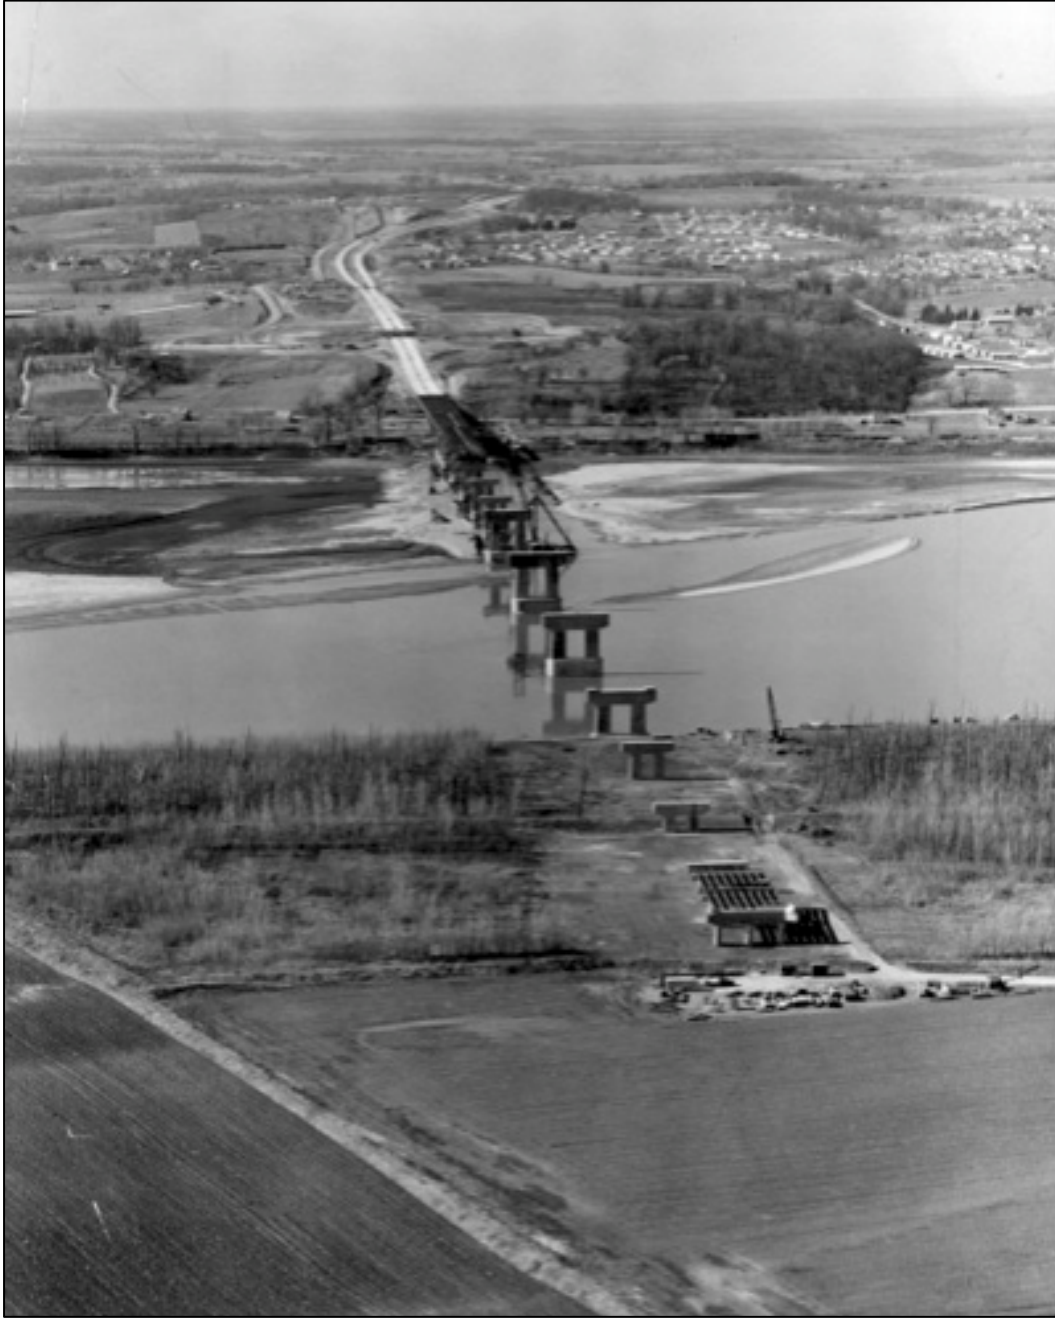
Figure 12. I-70 bridge construction over the Missouri River at St. Charles in 1957, view to the west (photo by Reynold Ferguson, St. Louis Post Dispatch).

channel into its now, relatively permanent position. Construction of the bridge began in March of 1955 before Bangert Island had formed completely. However, the main truss span of the bridge, with its widely spaced piers, only crosses the east half of the river, whereas the western span uses a girder bridge with smaller more closely spaced piers. A photograph of the bridge during construction in 1957 shows the completed piers and continued accumulation of sediment at the north end of the island (Figure 12). It is unclear when the old channel west of Bangert Island completely silted in, but it was effectively no longer an island by 1994 (see Figure 2). A small permanent tributary of the Missouri River, which drains the uplands south of downtown St. Charles, adopted the old channel along the north end of Bangert Island and drained northward to the river.

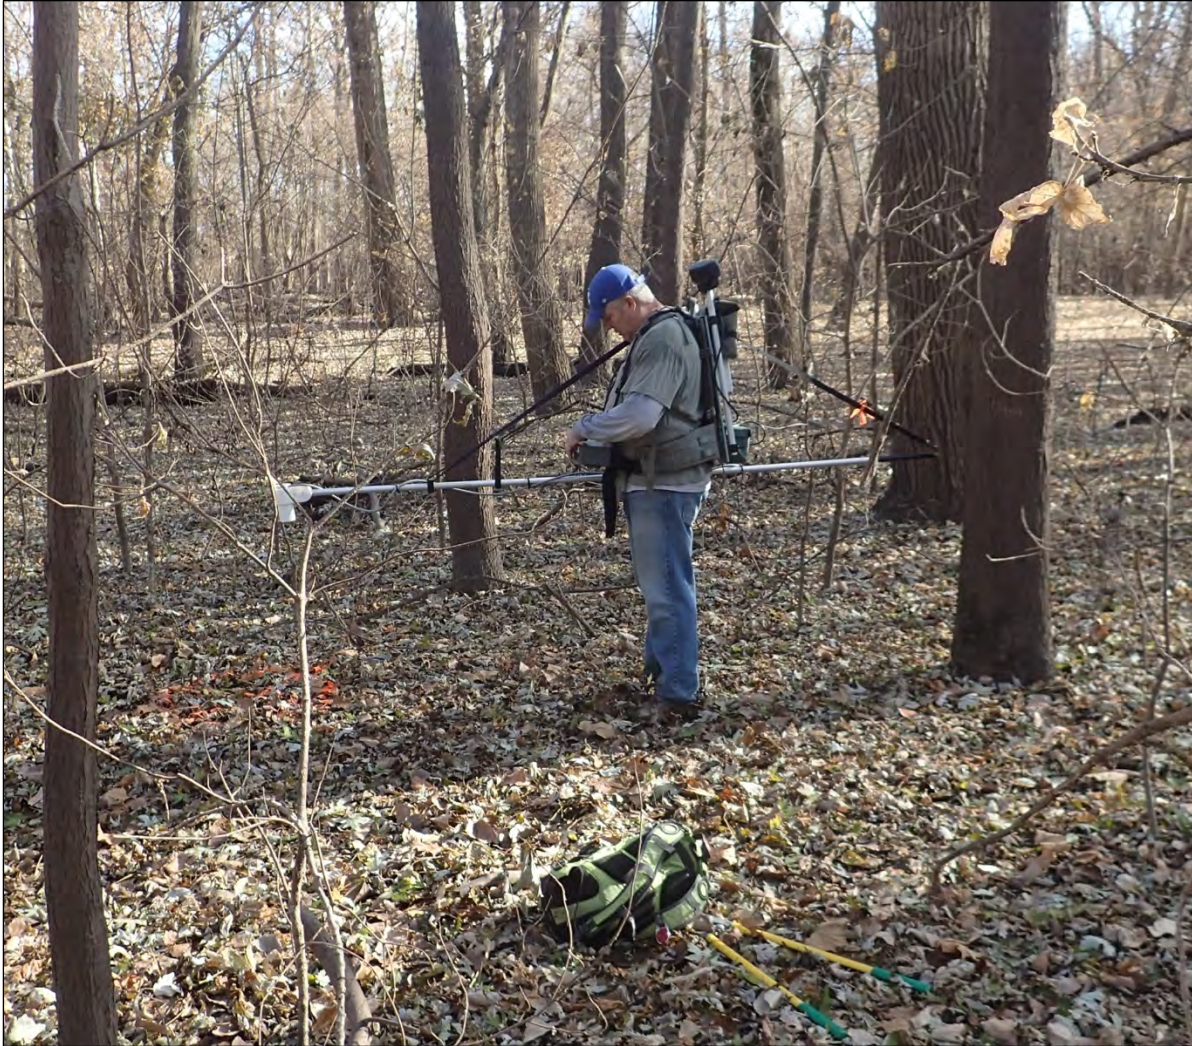
Figure 16. Photo showing the G-858 cesium magnetometer.

The Bangert Island survey involved the use of a (Geometrics) G-858 cesium vapor magnetometer strapped to the back and front of a surveyor (Figure 16). As with all magnetometers, the G-858 measures the intensity of the earth's magnetic field and anomalies often represent the presence of some ferromagnetic materials within that field. That is, the anomalies represent
