Technical Report M56

Bangert Island HSR Model Missouri River Miles 34.3 to 28.1

Hydraulic Sediment Response Model Investigation

Final Report – September 2011

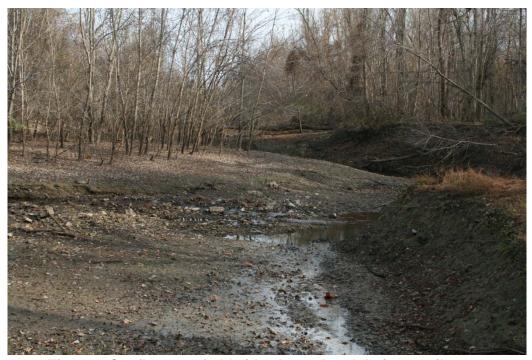
Figure 1 Confluence of old side channel and drainage tributary

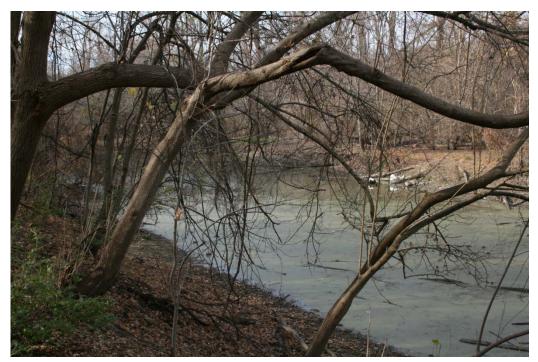
Figure 2 Old side channel southwest of confluence

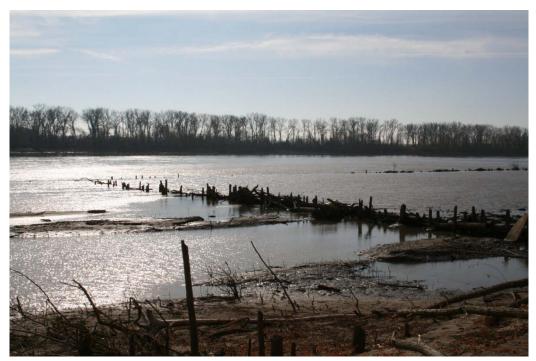
Figure 4 Pile dike on the Missouri

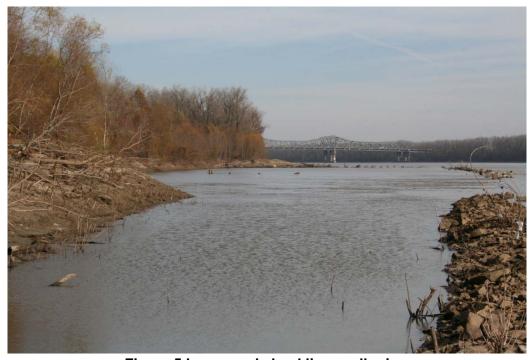
Figure 5 Large-scale bankline scalloping

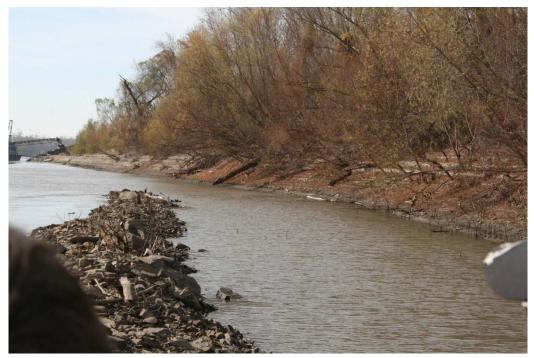
Figure 6 Upstream view of Missouri River bankline at proposed side channel entrance

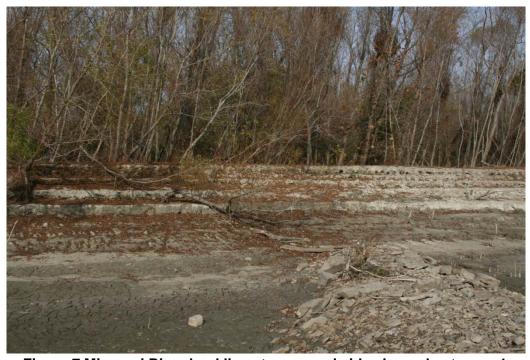
Figure 7 Missouri River bankline at proposed side channel entrance 1

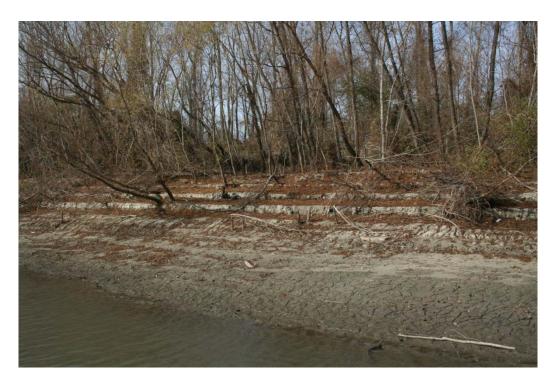
Figure 8 Missouri River bankline at proposed side channel entrance 2

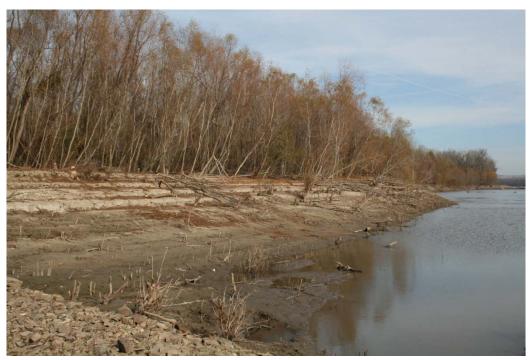
Figure 9 Downstream view of Missouri River bankline at proposed side channel entrance

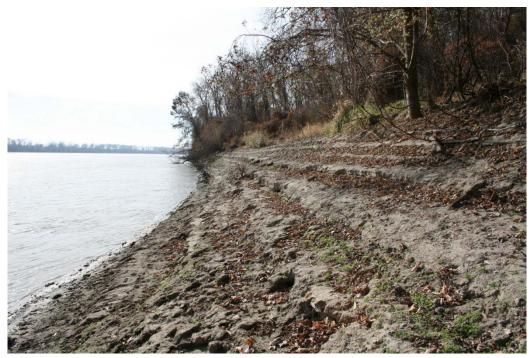
Figure 10 Upstream view of Missouri River bankline at proposed side channel exit

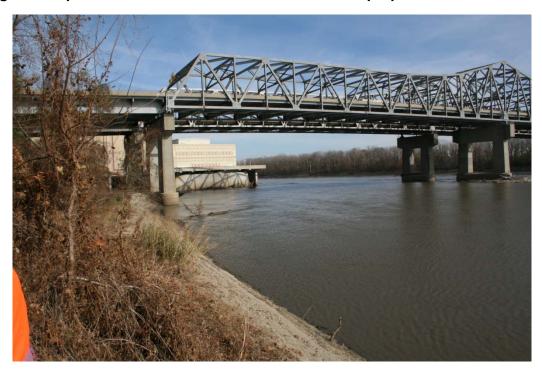
Figure 11 Downstream view of Missouri River bankline at proposed side channel exit
